1. PURPOSE AND SCOPE OF THIS MEMORANDUM

This memorandum summarizes a site survey performed on July 18, 2008 to evaluate the condition of ADA-mandated accessibility at the Town Hall in Pembroke Massachusetts. After a description of the site and interior conditions of the building, recommended improvements are provided in Section 7, beginning on page 8.

The subject property is the Pembroke Town Hall at 100 Center Street.

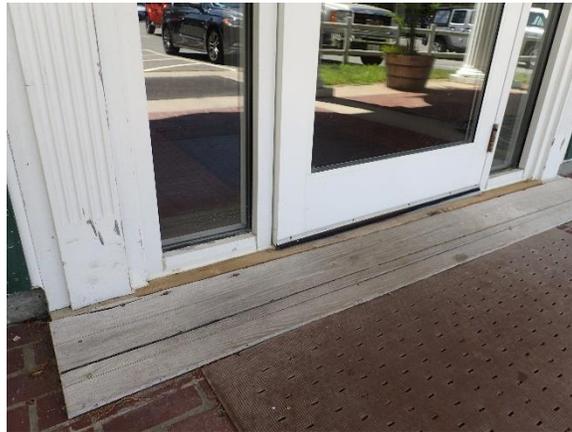
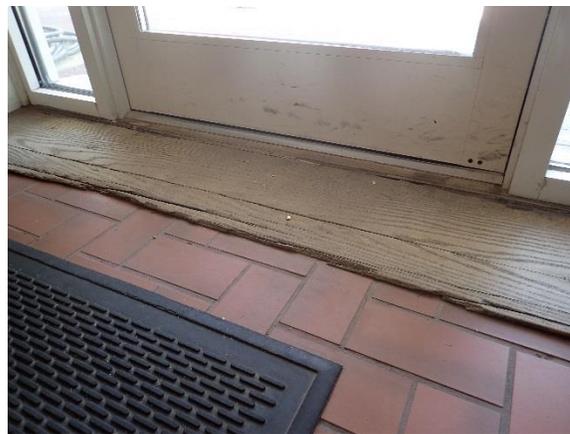
i. Door and Sill – Main (rear) entrance

The main (lower-level) entrance is generally accessible, but the door threshold does not fully meet ADA standards. It appears that there has been an issue with site flooding around the covered entry porch. The door threshold appears to have been retrofitted to control water intrusion into the building. There is a raised wood threshold at the interior and exterior of the door. This threshold is beveled on both sides, but well exceeds the allowable total height of $\frac{1}{2}$ ". The interior side if the threshold is also worn from use and exceeds the maximum allowable vertical step of $\frac{1}{4}$ ". The door, hardware and operation are otherwise compliant.

The main (lower-level) entrance door has a non-compliant threshold. This is not a complete barrier to access but may pose a challenge to some individuals.
 - iii. Signage and service locations

- a. Entrance Threshold – priority repair
As noted above, the door threshold exceeds the allowable ADA height. However, the deteriorated interior portion of the threshold should be replaced to provide a consistent edge with no more than a ¼” vertical step.

- a. Entrance Threshold
In conjunction with regrading and drainage improvements around the main entrance area noted above, provide ADA-compliant entrance door system, including threshold, plus new or modified door and hardware as necessary. ADA-compliant signage, including Braille lettering at power door operators, should be included.

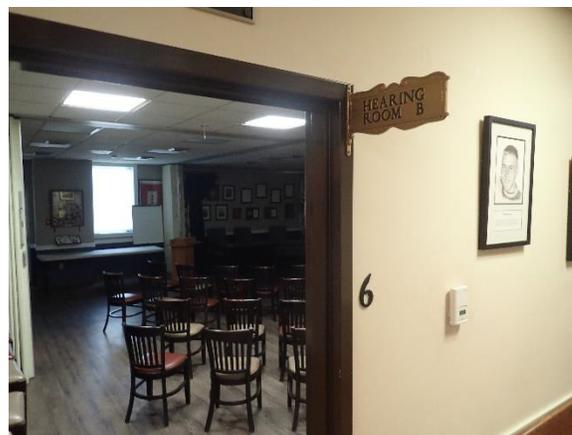
The interior signage at Town Hall does not generally meet ADA standards. Most permanent rooms and spaces are clearly identified, but the signage is typically high-mounted (in some cases, low-mounted) and lacks the required Braille characters.

- c. Interior Signage
Provide consistent ADA-standard signage for all accessible doorways, routes and spaces.
- d. Door Hardware – priority items
Provide lever-handle hardware at any doors expected to be used by the general public. Ensure single-action release (from the room or exit side) of doors subject to locking (i.e., no separate deadbolts, etc.)

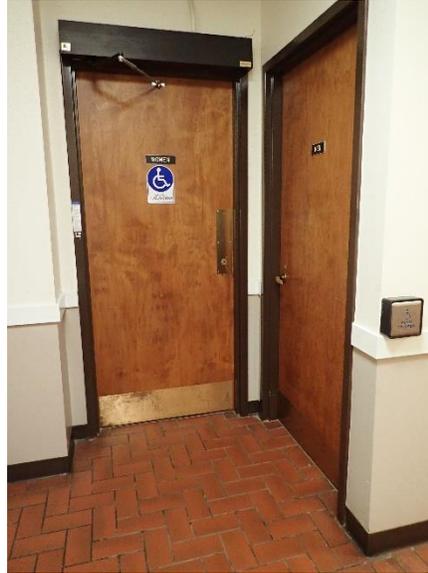
The two accessible toilet rooms, including their power door operators, are clearly marked, but also lack Braille characters. “Men’s” and “Women’s” toilet room signage is mounted too high and does not include raised or Braille characters.

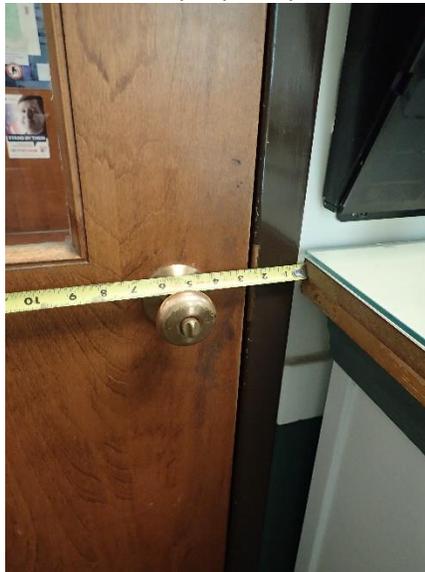
- Lack of appropriate hardware. Most doors have standard doorknobs, which cannot be operated with a closed fist or without grasping. Lever handles or simple push-pull hardware are required.

- b. Door Hardware – remaining locations
Provide lever-handle hardware at remaining doors. Include tactile warning on backside of handle at doors to hazardous locations
- c. Service Counters – transaction height
Provide permanent sections of all transaction/service counters at ADA-compliant height (36” or less). These sections should have the same approach path and access to customer services as higher-level counters.
- d. Door Clearances and Swings
Reconfigure or relocate door openings and/or change door swings to allow 18” clear at the latch-pull side of doors, plus 12” clear at the latch push side where the door is equipped with a closer.
- e. Alarm System upgrades
Provide audio-visual signaling at all required areas of the building.

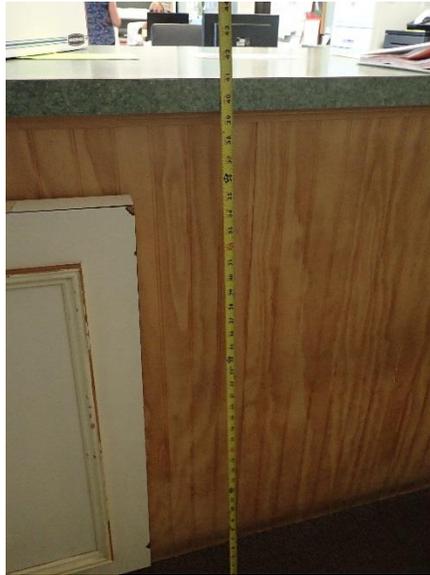
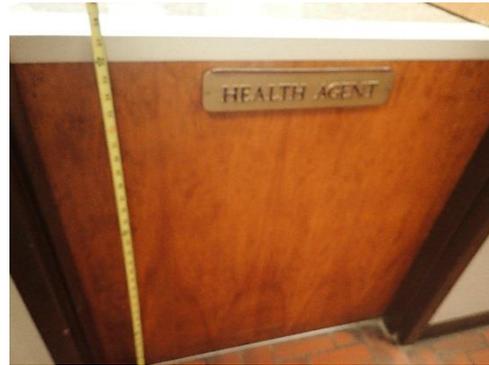
Height – transaction area

In several locations the transaction counters exceed the ADA maximum of 36"

- e. Service Counters – interim accommodation
Where ADA-accessible height (36” or less) counters are not available, ensure that alternate accommodation is available. This can include a desk or table of appropriate height in the same service area, equally accessible to all users. Furniture, including counters, should be moved to provide compliant door clearance and fully accessible routes.

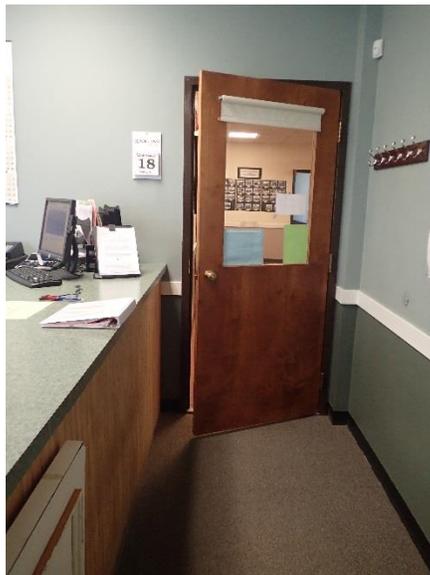
Access aisle – turnaround space

In some locations there is no open area within the room to allow a wheelchair to turn around

This is especially problematic in cases where the door swings into the access aisle space.

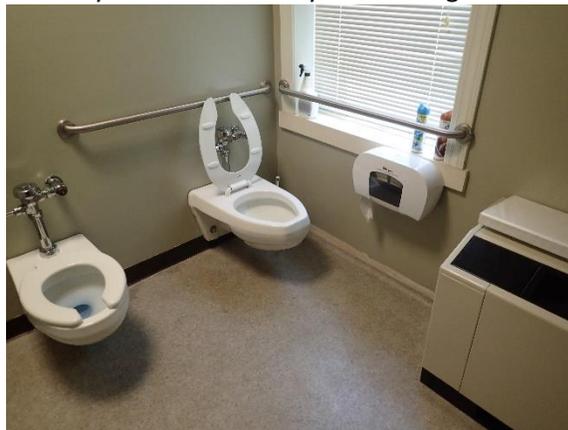
Upper Level Men's Room

This room is designated as accessible, and is provided with an automatic door operator. As noted above, the exterior signage is not ADA-compliant. The interior of the toilet room is non-compliant in several respects:

- The urinal is mounted higher than the 17" ADA maximum. The required 30" x 48" clear floor space may not be present.
- There are two toilets in the accessible toilet stall. This interferes with the required 60" minimum rear-wall clearance at the toilet, and may violate the State Plumbing Code (subject to verification of dimensions, this may be correctable by eliminating one of the toilets).

- The floor-mounted cabinet heater interferes with the required 56" minimum side-wall clearance at the toilet. (see comment above)
- The toilet compartment door swings out and lacks the required clear floor area and pull-side clearances. (subject to verification of

dimensions, this may be correctable by reversing the door to swing in to the compartment)

- The bottom edge of the mirror is mounted above the maximum 40" limit.

- b. Men’s Room Accessibility
The upper-level Men’s room requires several modifications to make it fully accessible: Provide ADA-compliant signage, including at power door operator
Reconfigure toilet stall to provide correct side- and rear-wall clearance, floor space and door swing. This will require the removal of one of the two toilets, and may require moving or changing the cabinet heater.
Rehang the urinal a maximum (lip) height of 17”. Ensure required 30” x 48” floor space is available and that urinal is no closer than 15” to a side wall or partition. Cut back interior drywall partition as needed to provide clearance for the 90-degree turn to the urinal.
Lower mirror to 40” max. above the floor.

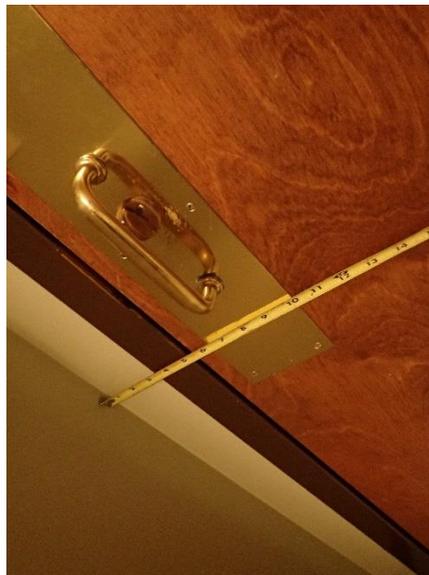
Upper Level Women's Room

This room is not identified as accessible, and was therefore not fully evaluated for compliance. However, it was noted that some effort has been made to provide accessible features (such as the lavatory, grab bars, etc.), but that full compliance would require modifications to at least the following items:

- Interior door latch (privacy deadbolt) interferes with pull handle clearance.
- Latch-pull side clearance at door is inadequate.
- Rear-wall grab bar is mounted at 38" AFF - ADA maximum is 36".
